# MEMORANDUM

**Project Title: Land at Cranesfield, Sherborne St. John, Basingstoke, RG24 9LN**  
**Response to LLFA comments contained within planning application consultation**  
**response (reference 25/02051/FUL) dated 13<sup>th</sup> October 2025.**

**Factual Ground  
Investigation Report**

**Project Name:** Land at Cranesfield

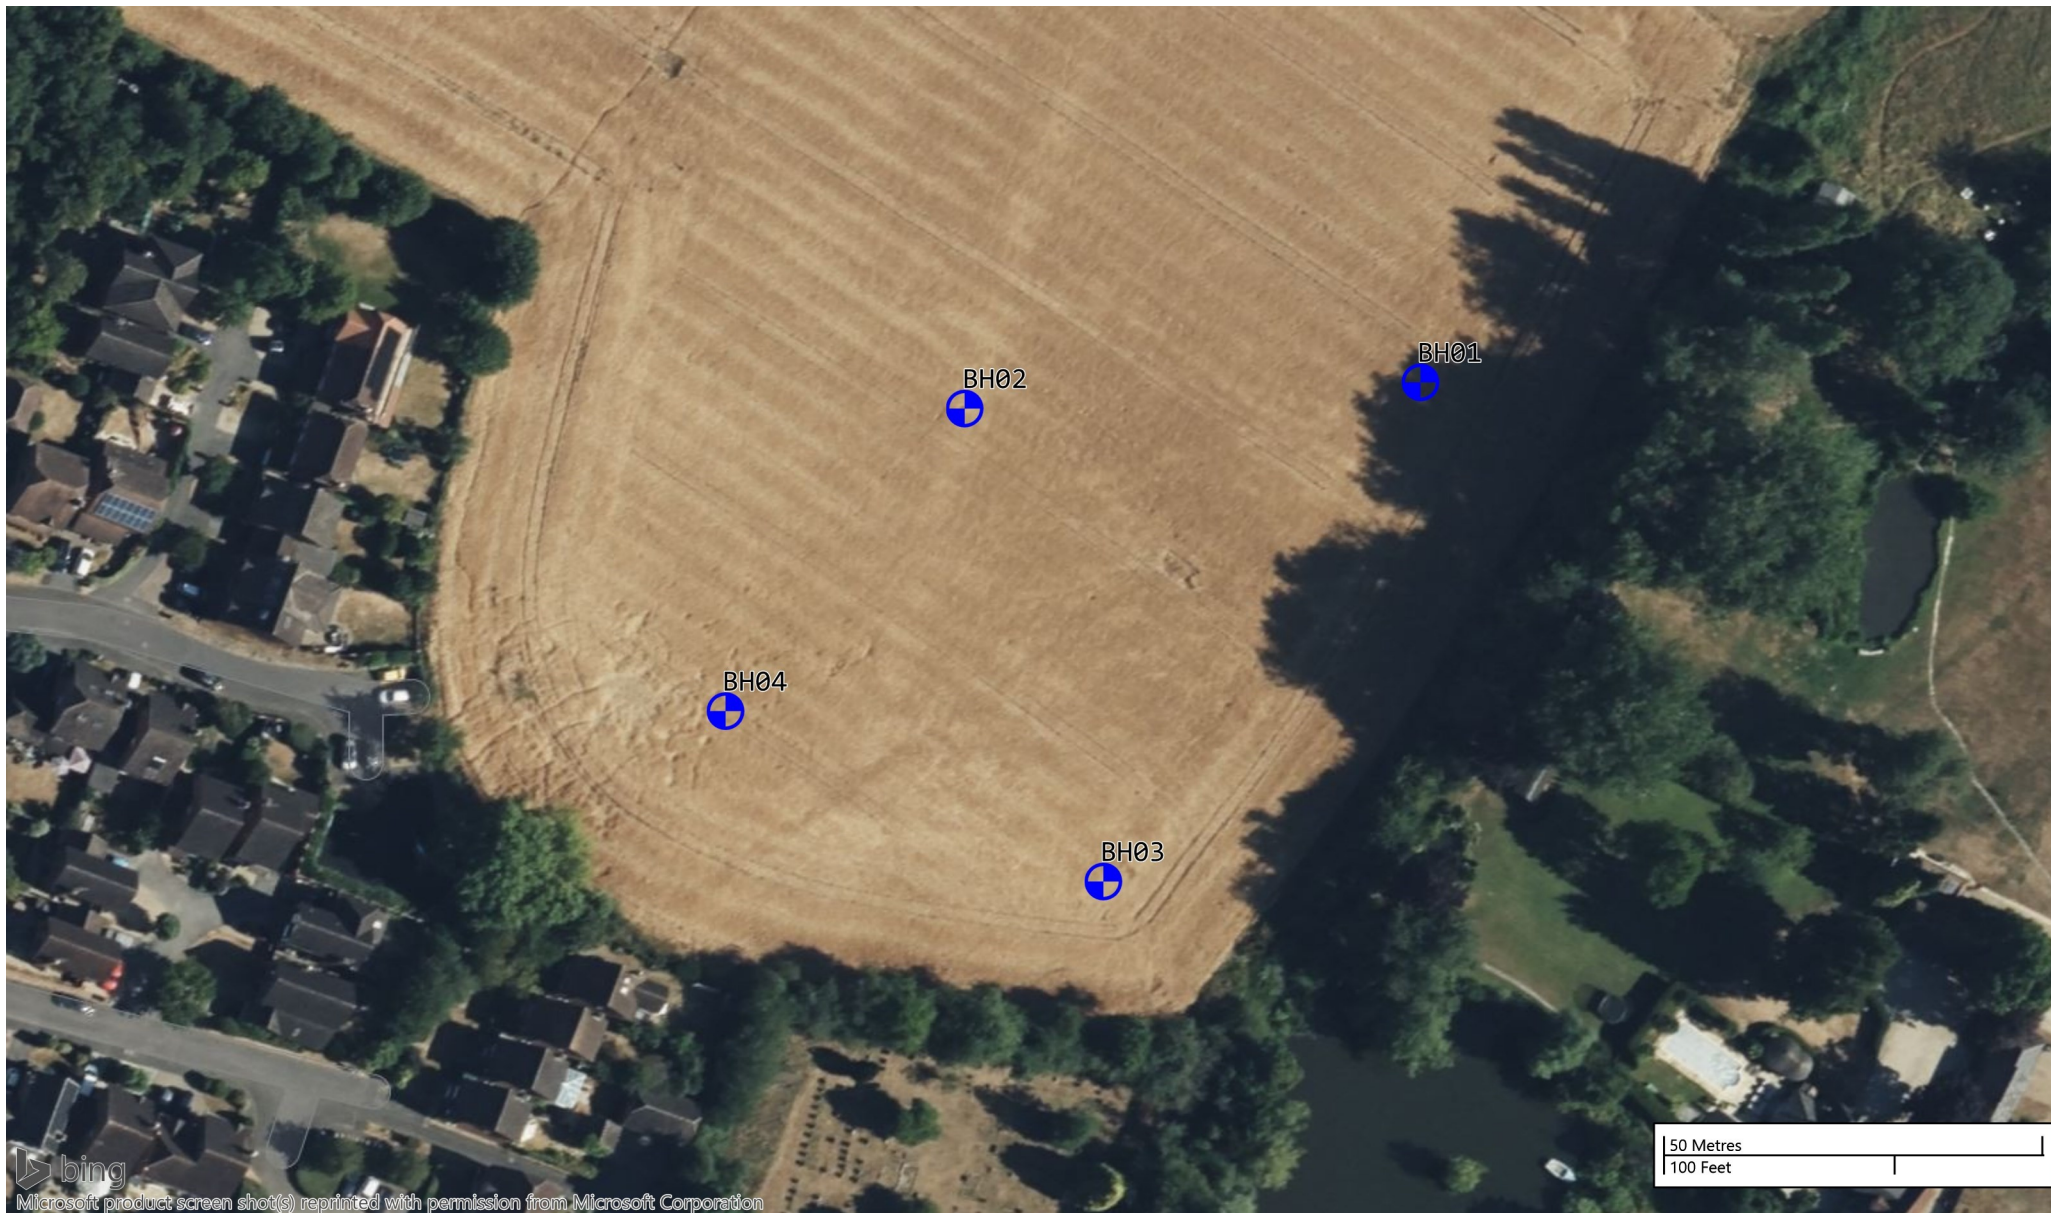
| <b>Project Name:</b> | Land at Cranesfield | <b>Project ID:</b> | J16117 | Figure 2: Borehole Location Plan<br> <b>Southern Testing</b><br>Environmental & Geotechnical |

Exploratory hole locations were specified by the Clients Engineer and are shown in Figure 2 in Appendix A.

Four cable percussive borehole (BH01-BH04) were carried out to 15m depth for installation of groundwater monitoring wells.

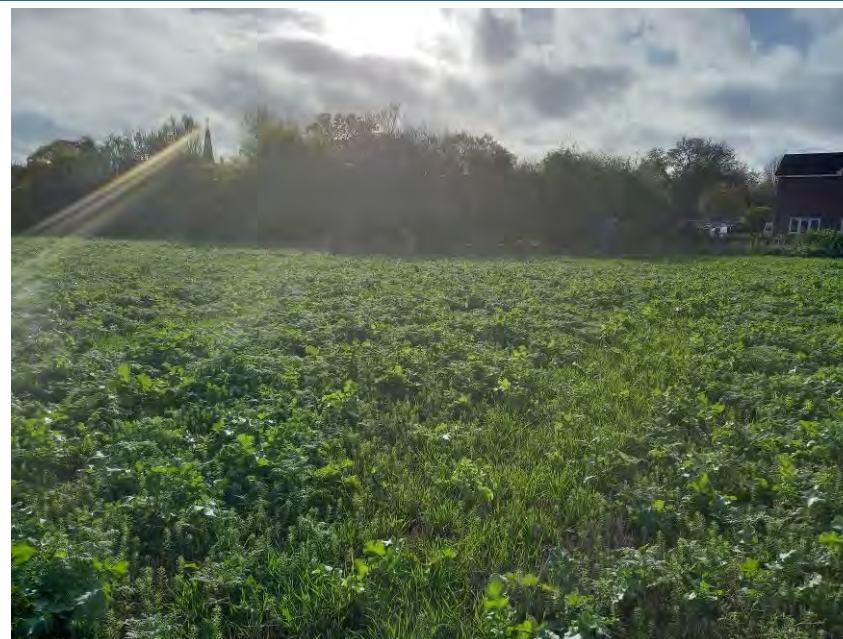
Borehole BH03 Location, looking east.

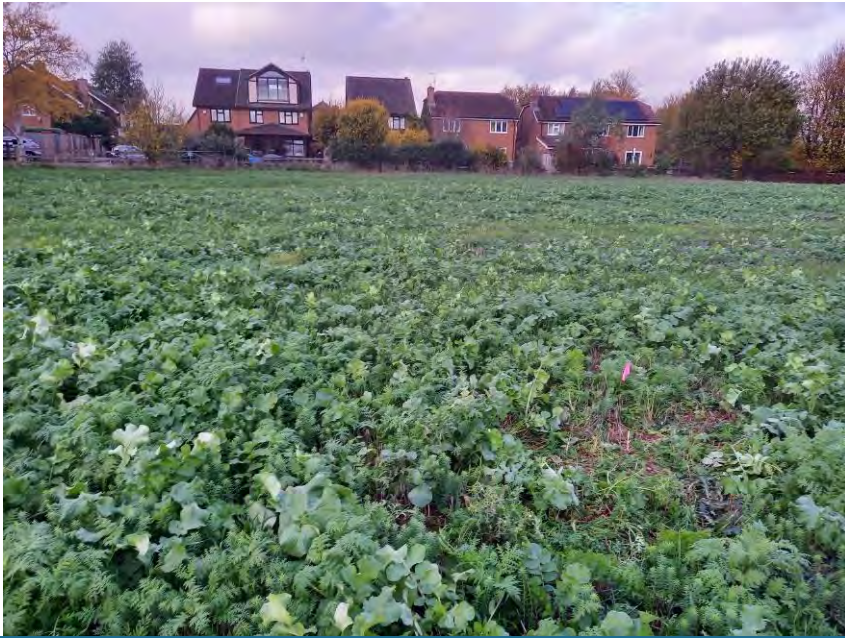
Borehole BH04 Location, looking west.

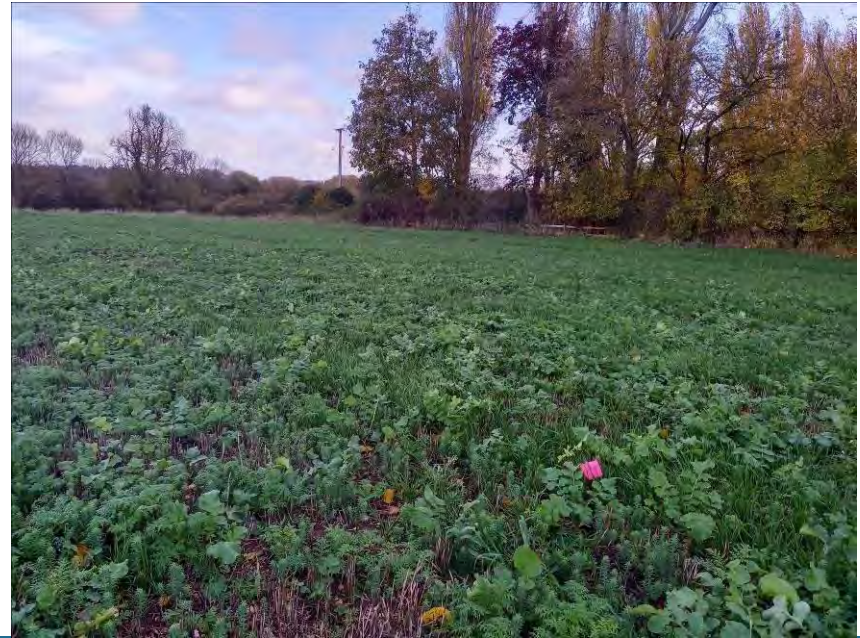
Borehole BH01 Location, looking north-east.

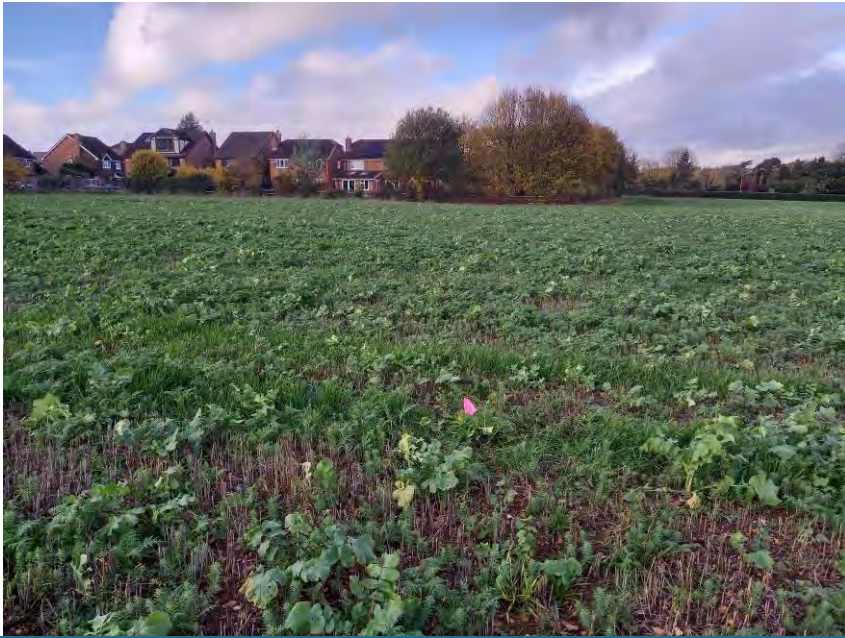
Borehole BH02 Location, looking west.
